RADAR INTERFEROMETRY TESTS OF THE BRIDGE RESPONSE DURING FULL TRAFFIC

Abstract: *This paper is devoted to measuring and evaluating displacements of the Prístavný most in Bratislava, Slovakia. It is a combined four-span highway and railway bridge with a length of 460.8 m. It is important to have knowledge of the functioning of the observed structure. Without a thorough and detailed numerical analysis, it is very difficult to correctly evaluate all measured data. Without detailed calibrated numerical models, in some cases it would not be possible to verify response of the structures. By comparing the numerical calculations and the measured data, we have the possibility to detect some structural defects that may not be visible. At the same time, we were be able to verify the impact of some non-structural elements of the structure on its behavior.*

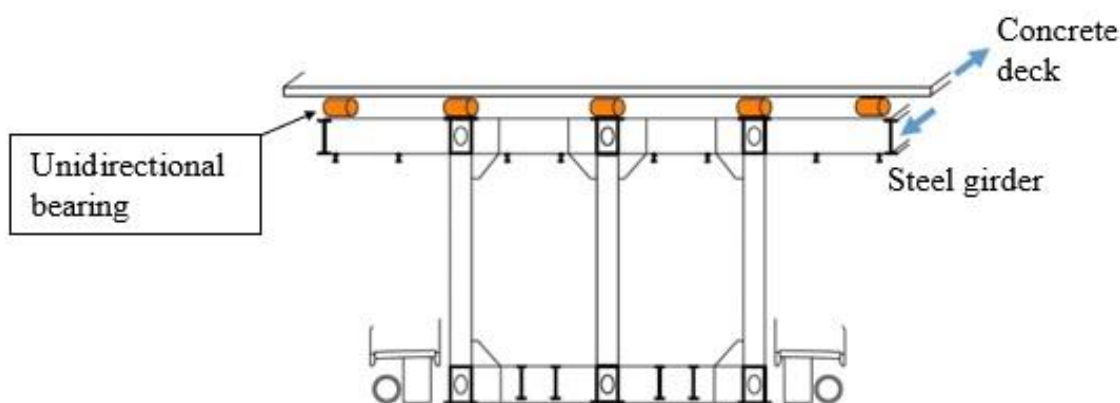
Fig. 2: Friction forces in bearings.

Since we do not know the condition of the bearings connecting the steel structure to the concrete deck, several alternatives had to be investigated numerically. The first alternative was that the bearings function perfectly, and therefore we consider the friction coefficient in the bearing with value 0.00. Another alternative was when we considered the opposite state and the friction in the bearing was 0.95 – 1.00. The last alternative was such a situation that the friction coefficient in the bearing was assumed with a value only 0.10.

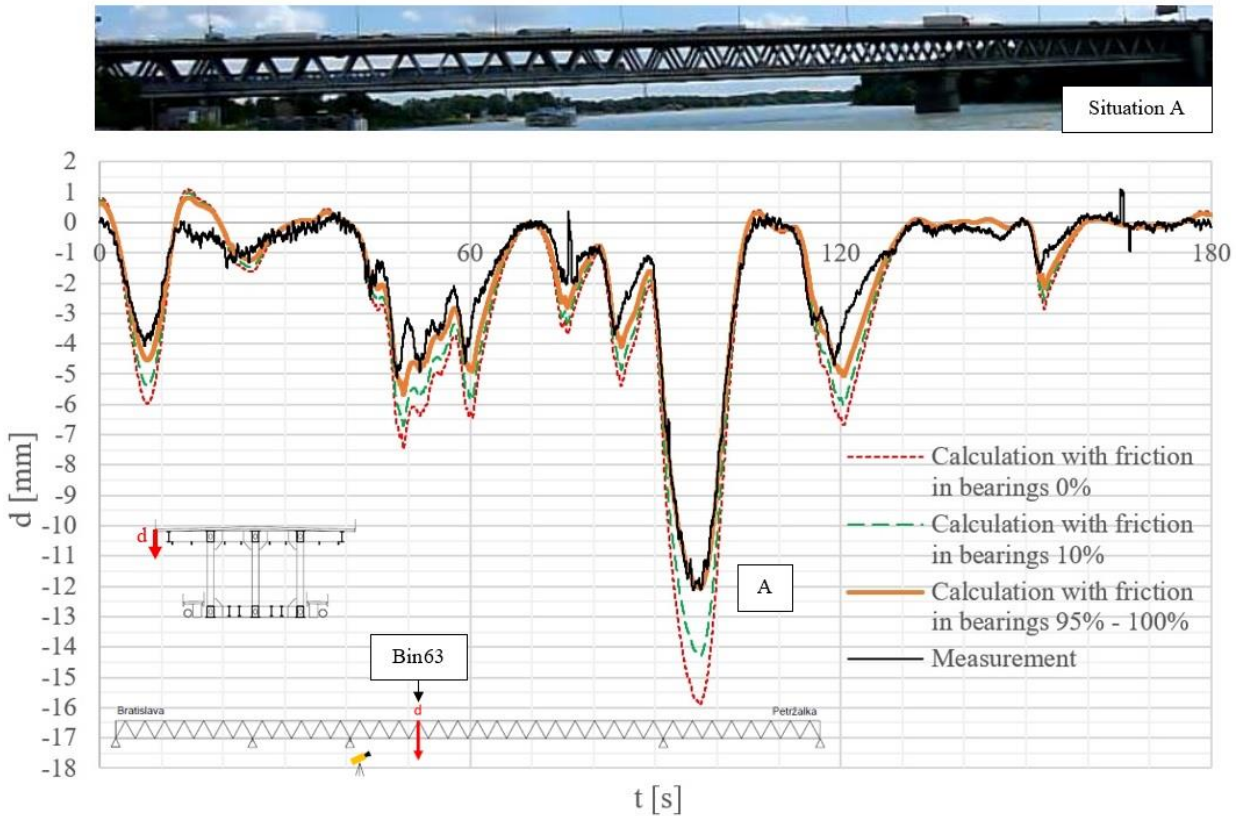
Fig. 3: Comparison of measured and calculated displacements.

Fig. 3 shows a comparison of the displacement record of the measured point Bin63 (black line) and the calculated displacement values with different friction in the bearings (friction 0.00 - red dotted line, friction 0.10 - green dashed line, 0.95 – 1.00 - solid orange line). Figure also contains a picture of the selected traffic situation at time t = 96 s, when the displacement of the Bin63 point was maximal. A more significant displacement between 90 s and 100 s causes the passage of a personal train (situation A) in direction form Bratislava, Ružinov. At the same time, there are several trucks on the bridge in the direction from Bratislava, Petržalka.

The maximum displacement of the measured point Bin63 in situation A d_{test} was 11.9 mm. Numerically determined values of displacements d_{num} of this point are shown in Tab. 1. The performance indicator (PI_d) according to equation (1) is defined to compare numerical results with test data. This indicator shows how the result of the numerical model corresponds to those from the test data.

The calculated values of displacements considering friction coefficient around 0.95 are in a good agreement with the measured quantities. According to the results summarized in Tab. 1, it is obvious that the friction in the bearings influences the results considerably. On average the friction coefficient reaches the value of about 0.95, otherwise differences between the test and numerical results are approximately 25 %.

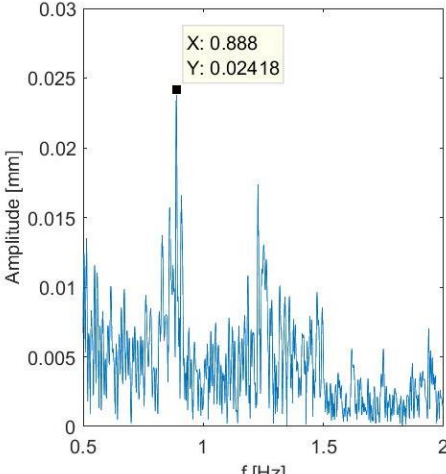
Using two independent measurements (using accelerometers and interferometric radar) and comparing them with a calibrated numerical model, we can assume that the bearings between the concrete deck and the steel cross members are for some reason non-sliding or only partially sliding. These bearings should be sliding in the longitudinal direction. This may be due to corrosion, pollution, poor maintenance, etc. Obviously, additional effects (stresses in the longitudinal direction) caused by the interaction of both parts are transmitted to the deck. Only after considering such a model did the size of the measured displacements approach the calculated ones, and the eigenfrequency of the vertical oscillation was equal to that obtained by the operational modal analysis. This allows us to state that the measurements are correct, and the numerical model is well verified and calibrated.
